A284 Lyminster Bypass (North) – Progress Update

Date: 1st March 2023

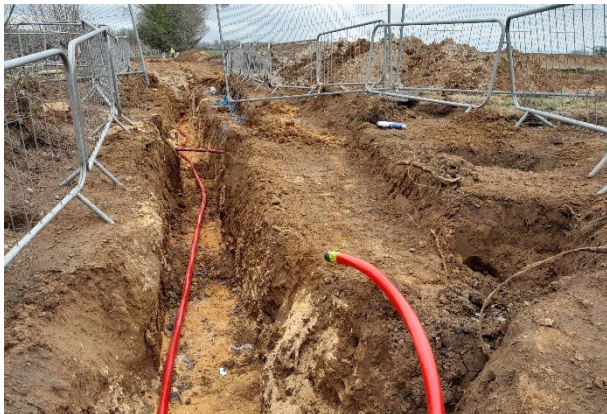
Figure 1: New HV Cable

At the start of the month the ducts for the HV diversion were put in, as well as digging the two locations for where the new HV route will be connected to the existing cable. The new cable has since been pulled through the duct and we are waiting for it to be connected and energised.

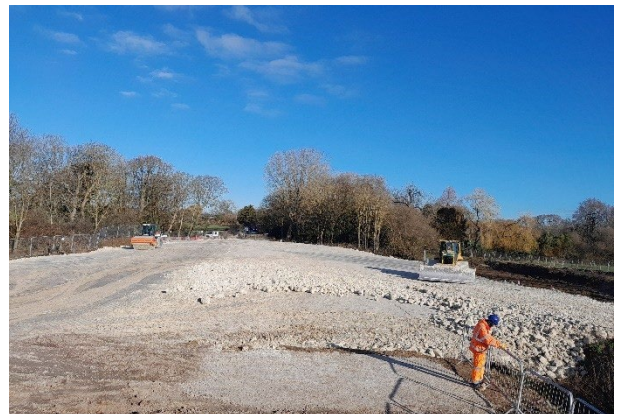
Figure 2: Class 1A Fill

Before we started bringing in the chalk, the period to get the piezometer (a ground pressure measuring device) baseline readings needed to be completed. This lasted for two weeks with no work taking place on the drainage layer. To allow us to have so many lorries of Class 1A fill to enter the band drain area we had to widen the existing access. From mid-February

we have been receiving deliveries of chalk and are continuing to build the material up in layers, this should be completed in two weeks (weather dependent) and will be followed by the placing of surcharge material.

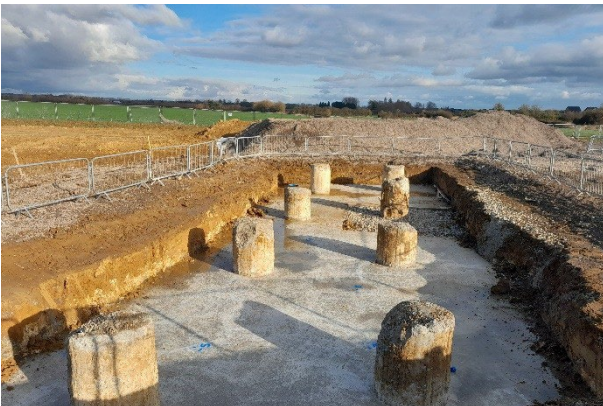
Figure 3: North Abutment dug down and blinded.

Piling for the viaduct on the north side was completed on 13th February. Other than the piling, during this time the temporary bridge piles were able to be broken down and blinded. Once our piling completed, the works on the north side of the black ditch, the piling mat was re-levelled and rolled so that a clean working area was created once again. The north abutment and pier 10 have been dug down and a thin concrete base has been placed whilst the temporary bridge abutment was poured. The piles are currently being cropped to the correct level before they will be tested.

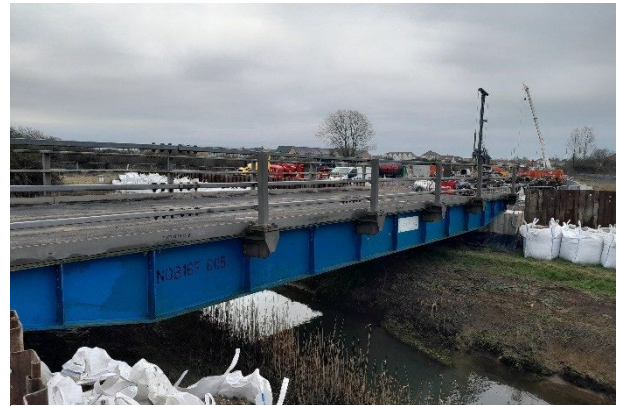
Figure 4: Temporary Bridge over Black Ditch

On Thursday the 23rd February, the temporary bridge was lifted into position and fixed to the abutments. Work is now being undertaken to build up the level of the piling mat so that it is flush with the bridge, and it can become usable for plant and pedestrians to cross.

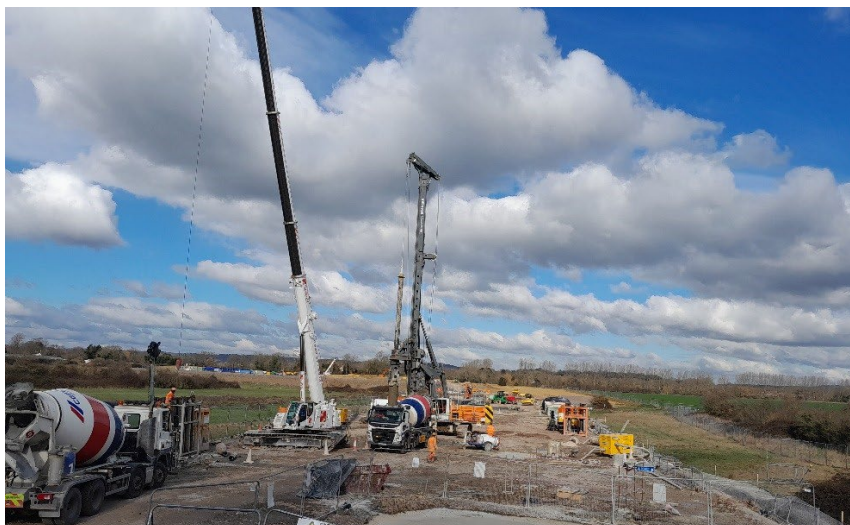
In the area south of Black ditch piling for the viaduct has continued. Similarly to the north of Black ditch, work was done to create the temporary bridge abutment. Upcoming works will

include digging the piers down and start to crop the piles.
