## A284 Lyminster Bypass (North) – April Progress Update

Date: 07/05/2024

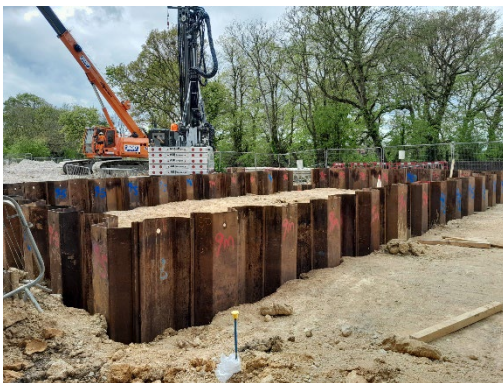
Image 1 Sheet piling.

Sheet piling has begun for the new culvert. The metal sheets are used to surround the culvert as it is installed. This is because a trench is dug out for the culvert and the metal sheets prevent it collapsing. These are installed using two machines which lift and vibrate the pile into the augured holes, the augured holes were made by churning the ground up to 9m depths to loosen it so the piles go in easier.

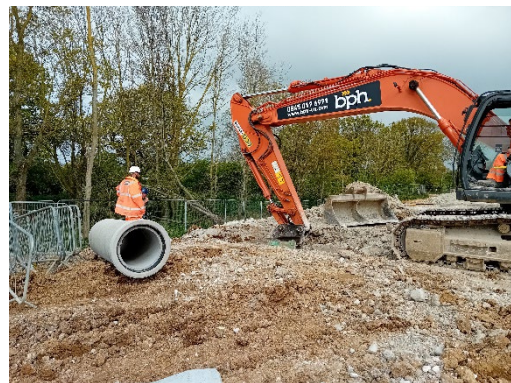
Image 2 Badger crossing dig out.

The chalk embankment just south of Brookfield stream has also been tested. The plate bearing test showed that the chalk was a very solid foundation and so further drainage works have continued. We have a badger crossing in this area, this is a 600mm diameter set of concrete pipes which run underground, with the idea of preventing badgers from wandering on the road.

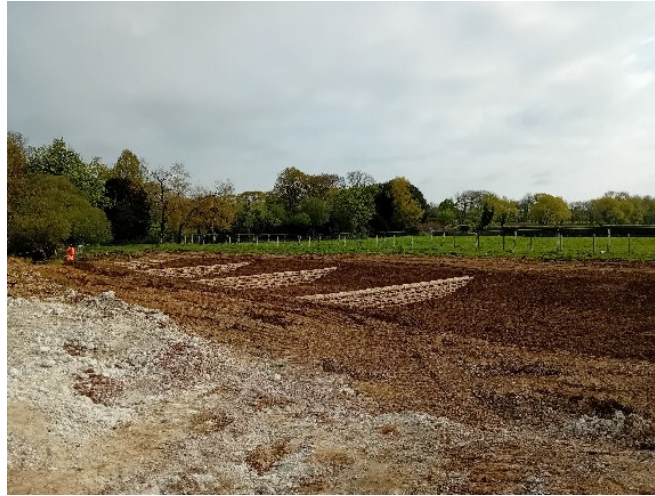
*Image 3 Swale with concrete check dams*

The northern swale has been built up, consisting of 4 check dams made by stacking concrete bags in a synchronised format. These are used to slow the flow rate of water which enters Brookfield stream, preventing a flash flood and provides extra storage for water.

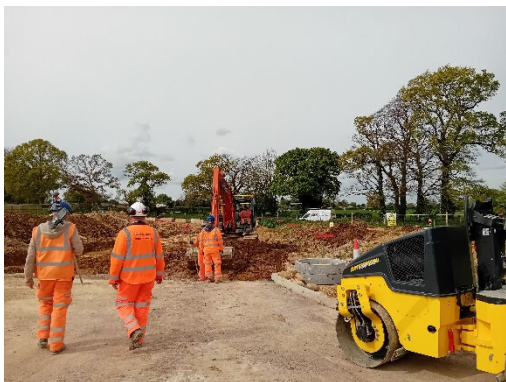
*Image 4 Link road.*

The link road has been scraped back to the formation of the subgrade material (the original ground material that was present on the site). Profile boards were used for this which is common practice to ensure the link road is to the correct level we use wooden profiles which run along both sides of the road. These are made up to be 1m above the finish road level. Once they are installed another board, is held in the middle. By eyeing along the boards, it can be seen how far down the ground level needs to be dug.

The subgrade material is tested with a CBR (California Bearing Ratio) test; applying a large amount of force to a localised area and recording how much the area settled. Once the test has been passed, the area is ready to be laid with the subbase material, type 1 aggregate (a type of limestone).

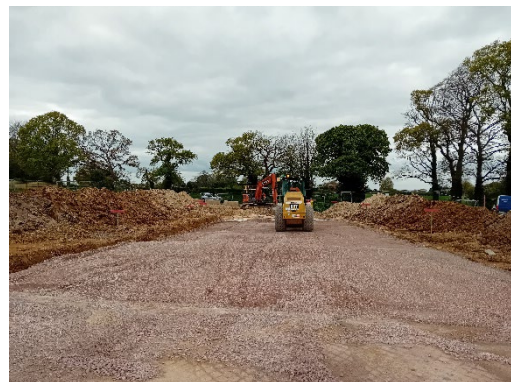
*Image 5 Link road with type 1 aggregate.*

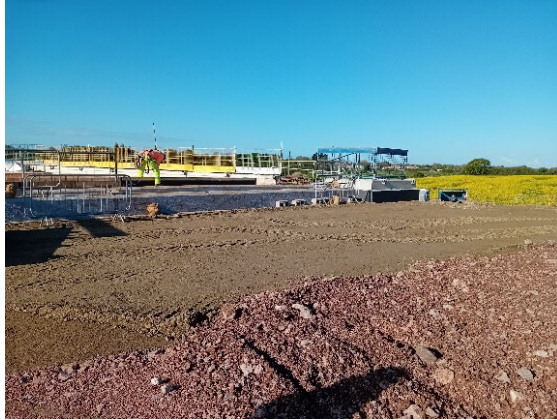
*Image 6 Northern end of the viaduct*

April finishes off our concrete pours on the viaduct. The ends of the viaduct have had a waterproof coating applied and the drainage along the edge wall has been installed, this is so the excess rainwater has somewhere to drain. The embankment by the northern end of the viaduct is being built up in layers and each is tested to prove it is sufficiently compacted.

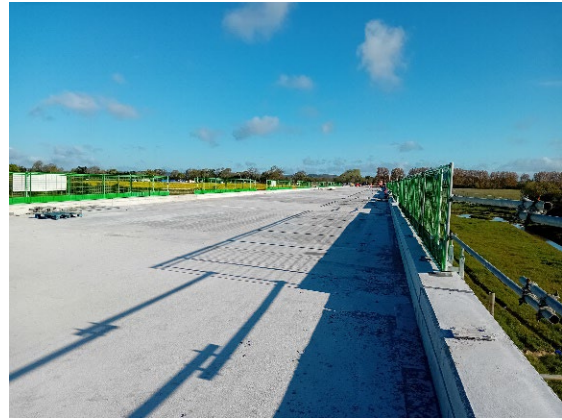
*Image 7 Concrete deck by the end of viaduct*

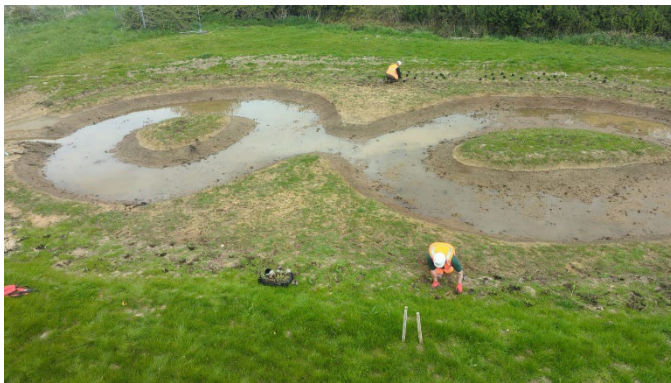
*Image 8 Aquatic plant bedding.*

As it is the season to plant aquatic plants, the southern pond has been attended to with 20 different plants being planted, this will increase the biodiversity of the area. The southern pond has been made to be a wetpond, this means it will have a pool of water throughout the year, allowing different species of plants and animals to thrive.

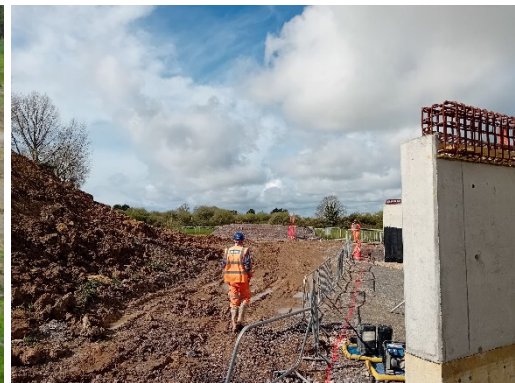
*Image 9 South abutment.*

The southern end of the project is being built up to the level of the existing road, this is so the area can be deep soil mixed, churning cement into the ground to improve the strength of the soil. The soil mixing will go right up to the south abutment as the ground material is currently a very soft clay.
