A284 Lyminster Bypass (North) – Progress Update

Date: 07/12/2023

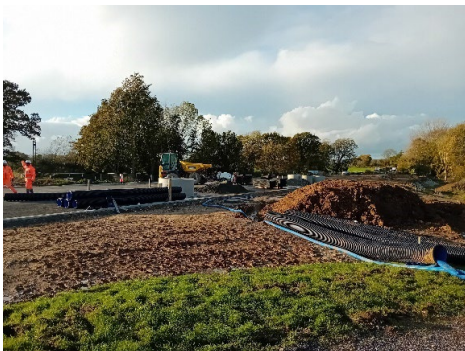
Image 1 Drainage pipes and pumping out ground water.

Now with all of the surcharge removed, drainage works have continued. Drainage pipes have been laid underground connecting each manhole. Now being in the 'rainy season', we are working hard against vast amounts of ground water flow filling into the trenches we dig. This water is then pumped back into the stream so our work can continue.

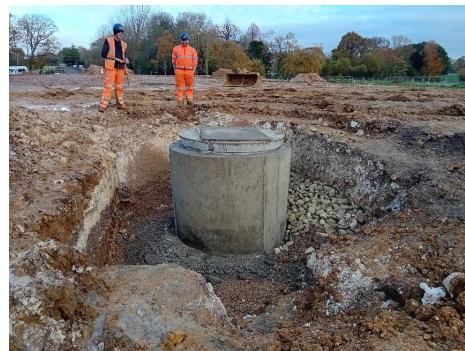
Image 2 Manhole for drainage.

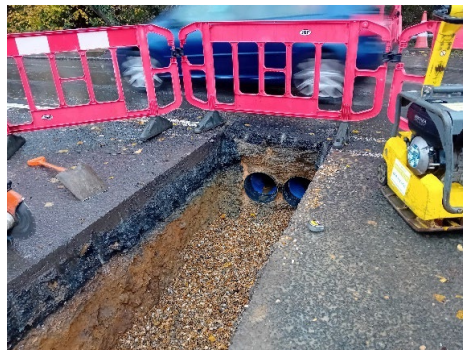
Image 3 Drainage for culvert into Brookfield stream.

Work has also been done on the A284, inserting two drainage pipes running across the road. This has been done in preparation for work starting on the new culvert in Brookfield Stream. The water running through the existing culvert will be temporarily diverted along these pipes into the other side of the stream, this is known as over pumping.

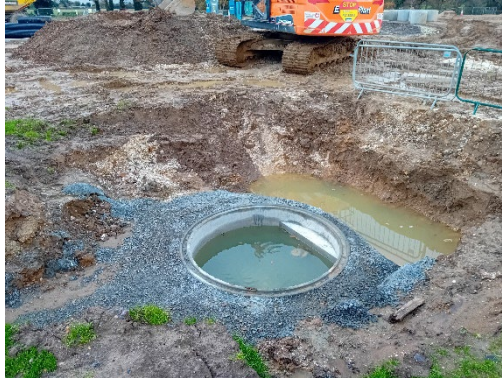
Image 4 Manhole draining northern pond.

Drainage work proceeds for the northern pond, a pipe has been laid coming out of the northern pond, draining the water into the manhole, before continuing through the drainage system until finally reaching Brookfield stream.

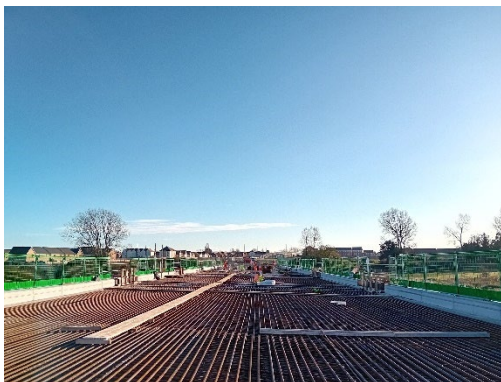
Image 5 Completed rebar.

Although increasing every day, we have now fully completed around one third of reinforcement steel work on the bridge, and the first concrete pours. We started in the middle of the bridge and are working our way outward. Care has been taken to seal the base of the deck, ensuring it is watertight to protect the environment. This shields Black Ditch from any concrete grout loss or water leaks.

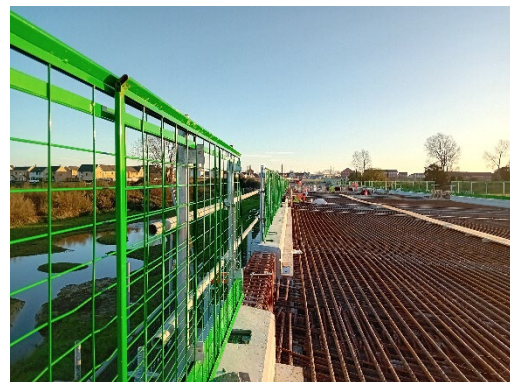
Image 6 Final parapet ready for concrete.

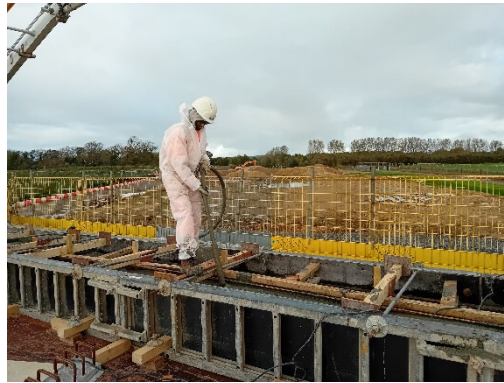
Image 7 North abutment concrete pour.

The concrete for the northern abutment back wall has been poured and the wing wall rebar has been completed, ready for their pours.

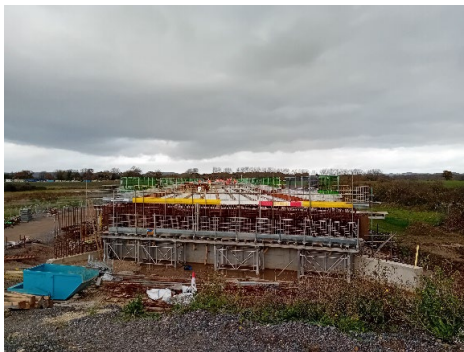
Image 8 Bridge progress facing North.

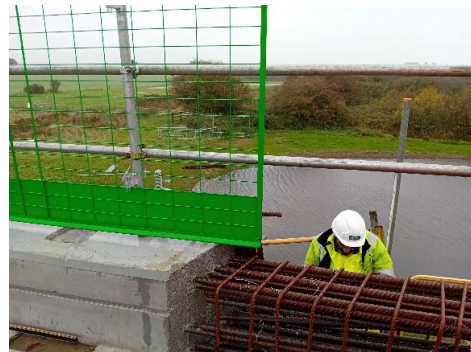
Image 9 Steel work on parapet wall.

Steel reinforcement bar work carries on at the bridge both North and South of black ditch. Steel reinforcement work has been focused on the parapet walls and diaphragms. The diaphragms are the spaces between the larger horizontal beams, making up the deck, and are constructed of concrete with steel reinforcement bars. They provide the connection between the bridge deck and the piers below. There have also been the first two diaphragm concrete pours. Each load of concrete delivered is tested for its consistency using a 'slump test' as well as taking samples used to check the strength. This ensures we have the desired strength and finish and the viaduct is safe for use.

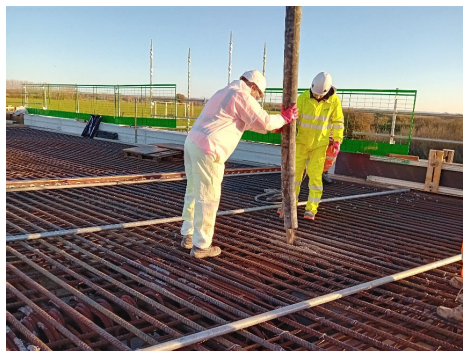
Image 10 Diaphragm concrete pour.
