A284 Lyminster Bypass (North) – August Progress Update

Date: 29/08/2024

A284 Lyminster Bypass (North) – September Progress Update

A284 Lyminster Bypass (North) – October Progress Update

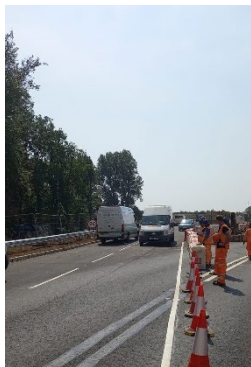
Image 1 Traffic switch

A lot has happened this month to the North of our site. We began with the road diversion on 2nd August which now carries the traffic along a section of what will be the new carriageway. The site team spent all day ensuring the switch went smoothly and as planned, and it did.

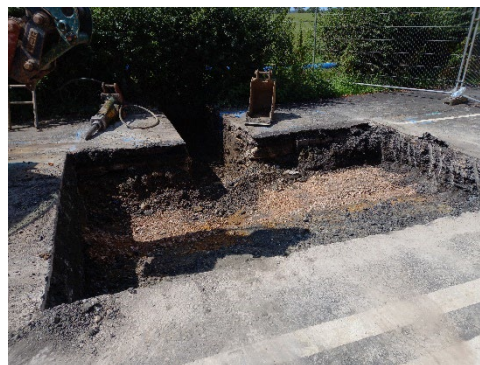
Image 2 Exposing water mains

The traffic switch allowed us to access the existing road initiating the start to Phase 2 of the Culvert works. This has included digging out and exposing the water mains which ran under the existing road and installing a new pipeline which will run across the back of the culvert temporarily. The mains water was turned off for 3 hours so the diversion was able to happen. They are yet to cut off the current water pipe, leaving the temporary pipe in full flow.

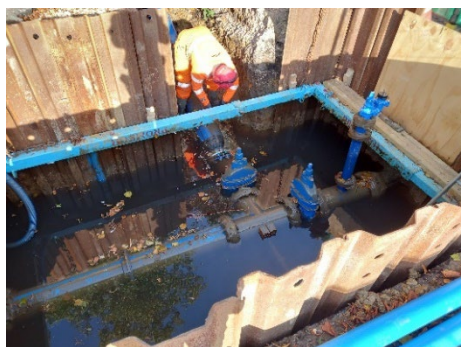
Image 3 Water diversion

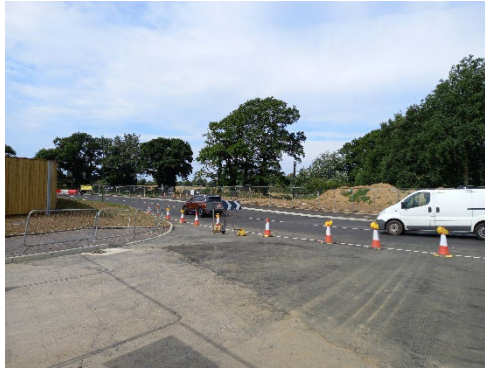
Image 4 Traffic switch

The only works in this section has been the traffic switch due to all the current works being completed here and a run of live traffic on the carriageway now.

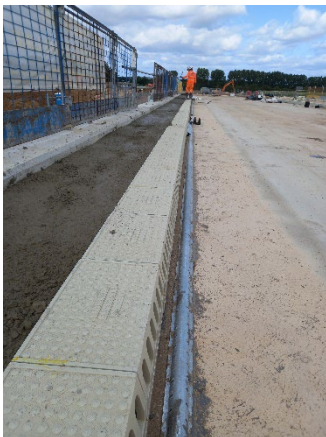
Image 5 Drainage on the viaduct

The remaining combined kerb drainage units have been installed on the viaduct as well as a majority of the subsurface drainage. The subsurface drainage is built up from half pipes welded to flat plates, adhered to the waterproofing on the deck. Along the runs there are access boxes that have been cut down to suit and concreted into position to make flushing points through the system. We have then been able to pour the concrete infills making the base of our cycleway/footpath and verge next to the road.

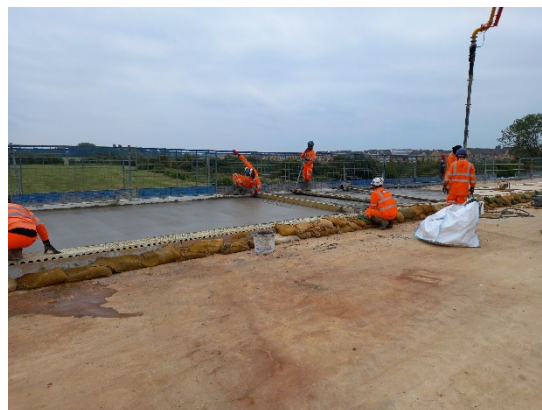
Image 6 Verge infill pours

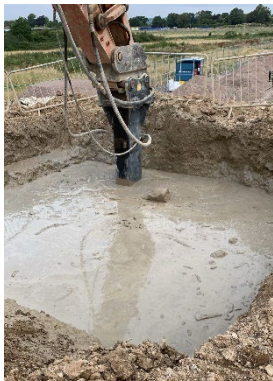
Image 7 Deep Soil mixing

The soil improvement was completed this month by the south abutment. This process is employed in challenging ground conditions to enhance the area's properties. It involves blending the existing soil with cement and GGBS (a cement-like substance). It underwent CPT (Cone Penetration Tests), PLT (Plate Loading Tests) and cores from the ground were taken to be strength tested, all to ensure the foundation is solid enough for the works to continue.

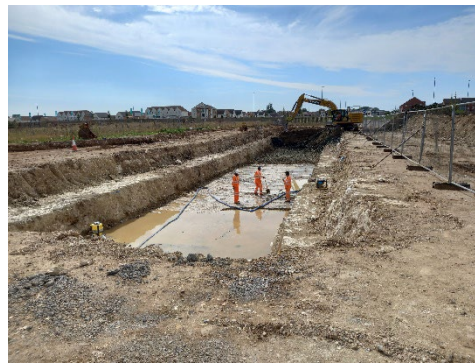
Image 8 Digging out for Attenuation tank

After these works were completed, we have been able to begin digging out where an Attenuation tank is going to be installed. These are flow control chambers that manage the amount of water going in and out of it. They prevent the area flooding as it is where all the drainage systems flow to. As well as this, we have had a large amount of muckaway removed from site from the dig out for the tank, as well as the excess material from the soil mixing.

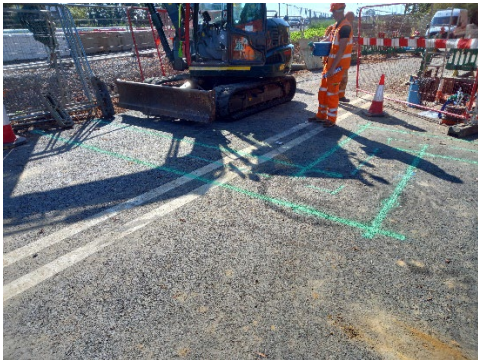
Image 1 Saw cuts in tarmac

For the next stage of the culvert, we have now saw cut the existing tarmac along the lines where the sheet piles will be driven in next month. This is to allow our team to carefully break away the unwanted tarmac whilst still leaving a platform in the middle for the piling rig to sit, minimising the size of the machine needed.

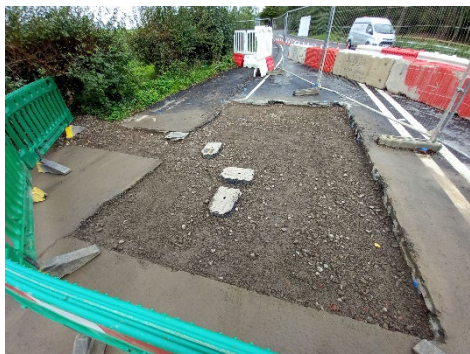
Image 3 Complete water diversion

As well as this, after getting positive results back from Southern Water regarding the quality of the water through the new pipe, the existing water mains has been capped off and cut, now leaving the water to run through the new diversion out of the way of our works.

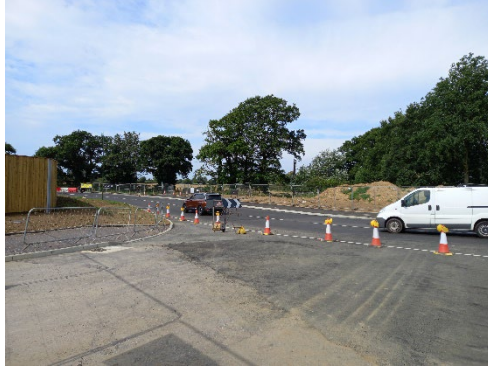
Image 4 Live road

No works occurred in this area, the traffic switch remains live and is running smoothly with no interruptions.

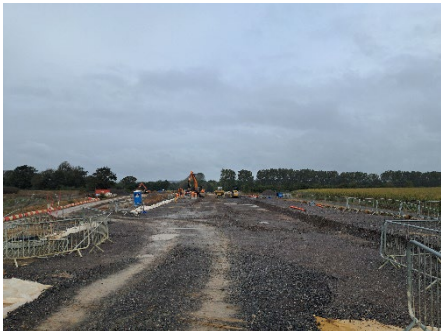
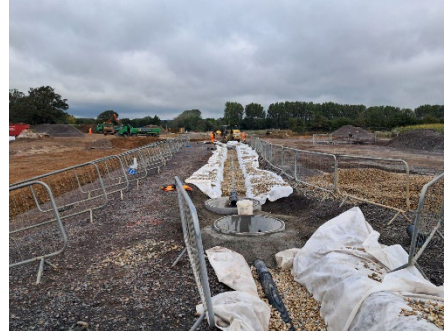
Image 5 Embankment and drainage works

Image 6 Embankment and drainage works

The embankment to build the road up to formation level has been constructed this month. It is made from a class 1 granular material and has now been brought up to a level where the drainage can be installed completely. The perforated pipe has been installed on the West side already where the excavation is filled with shingle to allow the surface water to drain into the system.

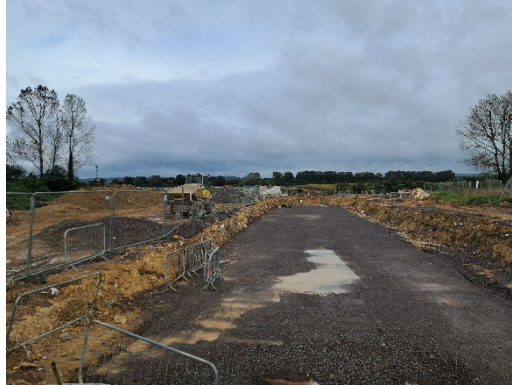
Image 7 Continued Attenuation tank works

Behind the abutment, the attenuation tank works have continued. This has involved placing plastic crates with voids, wrapped in a waterproof material, down in the ground to hold any excess water as when the rain becomes heavy enough it avoids the water flow entering the natural watercourses and flooding.

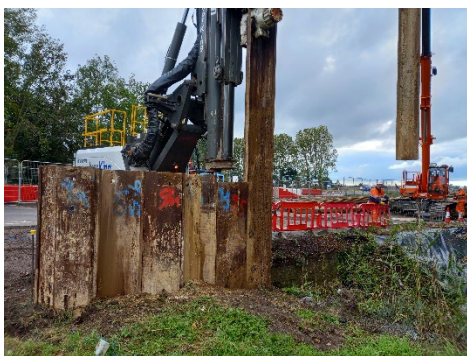
Image 1 Sheet piles being installed

Despite some challenging weather in the last few months, some good progress has been made regarding the culvert works at Brookfield Stream. At the beginning of the month a number of interlocking sheet piles were driven into the ground creating a closed loop called a cofferdam around the extents of where the culvert will be installed. This has allowed us to safely break out and remove the existing road and excavate the ground underneath. The next step was to improve the strength of the foundations/ground using the same soil improvement technique as previously used on this job. We are now currently in the process of digging out the soil improvement material down to the correct level so the new pre-cast concrete culvert units can be installed whilst also providing a safe working space for the site team.

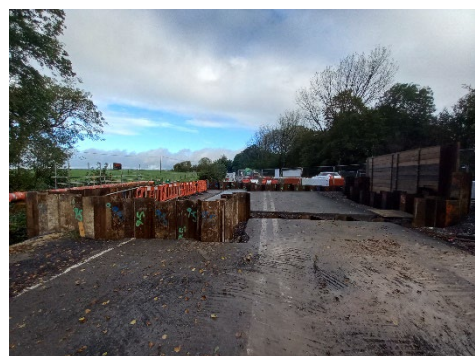
Image 2 Cofferdam installed

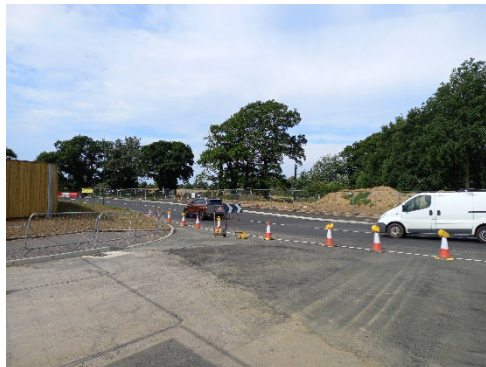
Image 5 Live road

The acoustic fencing was completed in this area. The traffic switch remains live and is running smoothly with no interruptions.

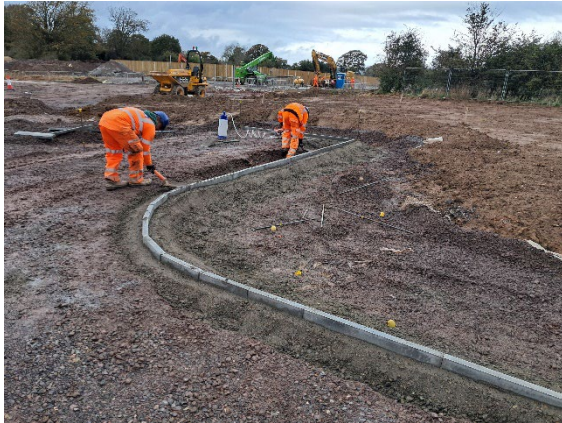
Image 6 Embankment and drainage works

The embankment has now been built up awaiting the final road surface to be placed on top. The footpath along the eastern side has been completed, with installation of the concrete borders of a footpath marking its edges. Pre-cast concrete drainage units have been installed to allow the drainage of water to run off the road and into the drainage system, which has been connected to the existing channel kerbs on the north side of the viaduct.

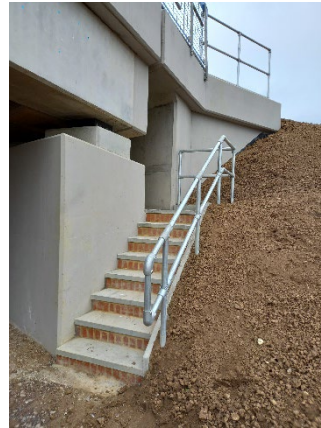
Image 7 North abutment stairs

On the north of the viaduct the stairs up to the abutment gallery – to be used for maintenance of the viaduct – have been installed including a handrail system running up the side.

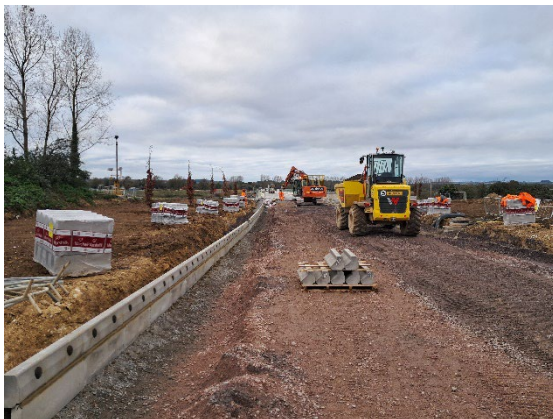
Image 8 Progress on the South

The soil and mixed materials were levelled to create a solid base for the road. A layer of Terram (a geotextile material used to keep materials separate when layering them) was then added to help with the compacting process for the Type 1 material, which serves as the main foundation layer of the road. This Type 1 layer, a specific class of graded stone with the required properties, was then spread out, shaped to match the shape of the road, and thoroughly rolled to ensure it was well-compacted. Finally, more concrete drainage units, were installed along the edges to help direct water runoff and define the road boundaries.

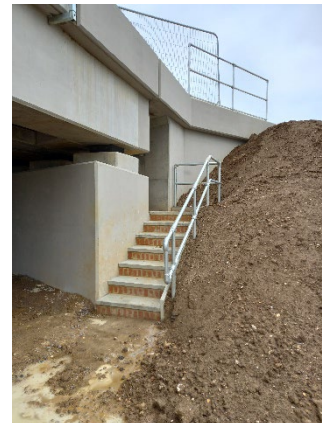
Image 9 South Abutment stairs

We have also installed the stairs on the south of the viaduct with a handrail system running up the side.

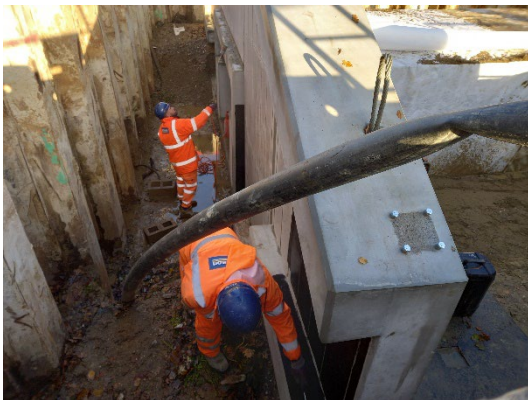
Image 1 Culvert units being installed

This phase of construction focused on installing the culvert units, which comprised six sections made off-site and designed to connect, including one concrete headwall and four structural concrete wing walls, all of which were safely placed in using a 250-tonne crane on a carefully prepared bed of 6N material. This is a granular fill that compacted to provide a stable and reliable foundation for the culvert system.

The wing walls are designed to provide additional support and to channel water effectively into and out of the culvert, helping to prevent soil erosion and maintain the integrity of the surrounding area. In addition, the headwall was installed at the culvert outlet to reinforce the structure and manage water flow more efficiently.

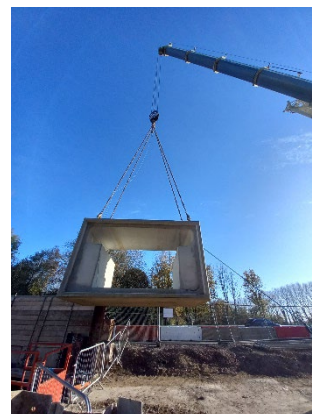
Image 2 Crane lifting precast units

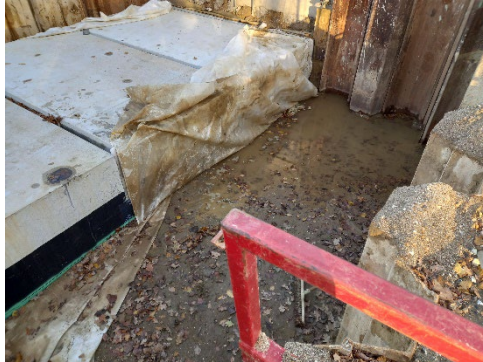
Image 3 6N Backfilled

Once these key elements were in place, the surrounding area was backfilled with compacted 6N material to stabilise the culverts and ensure the system was well integrated into the landscape. To shield the culvert units from water entry and lengthen their durability, a product used to create a waterproof barrier named Blackjack was applied to the outer surfaces, creating a robust seal and ensuring the system's durability.

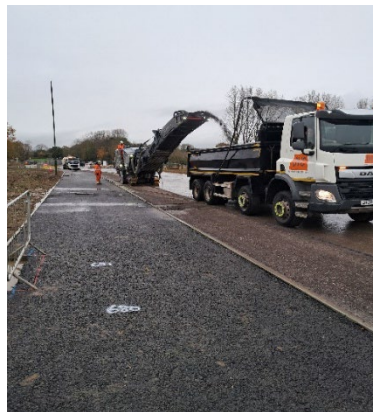
Image 4 Planing tarmac

Along the carriageway leading to the bridleway, we applied an additional layer of tarmac to withstand the heavy traffic from construction activities. This protective measure ensured the underlying road surface remained intact during the building phase. After this period, we employed a technique called planing to remove the excess tarmac, effectively smoothing out the surface in preparation for the final layer of tarmac. This process was both efficient and cost-effective, streamlining the preparation without the need for more intricate methods.

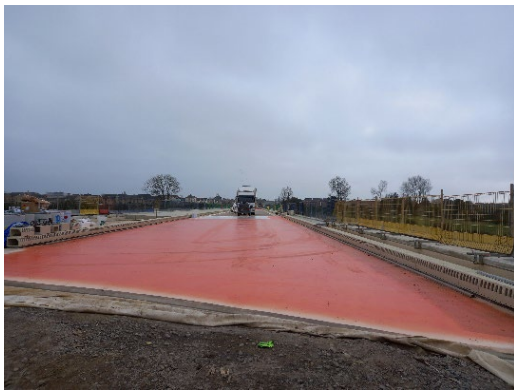
Image 6 waterproofing on the viaduct

This month a multi-layer waterproofing coating system (with a red top layer in photo) was successfully applied to the deck of the viaduct before we were able to apply any tarmac. This layer system is essential as it prevents water from seeping into the concrete viaduct structure, protecting it from potential damage over time. The tarmac layers were then laid in stages to ensure the road is well-protected, durable, and drains effectively.

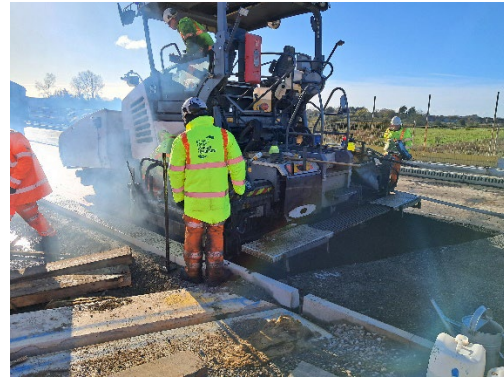
Image 7 Tarmac getting laid on the viaduct

Tarmac began with a layer of Hot Rolled Asphalt (HRA) applied. This type of asphalt is very strong and designed to last a long time. It also provides a safe, non-slip surface for vehicles. To give the road its different sloped surface, known as the camber, which allows water on the road to drain off into the Combined Drainage Kerbs, two layers of binder material were added. These layers were carefully shaped and compacted to make sure the road drains water properly and remains strong enough to handle the weight of traffic.

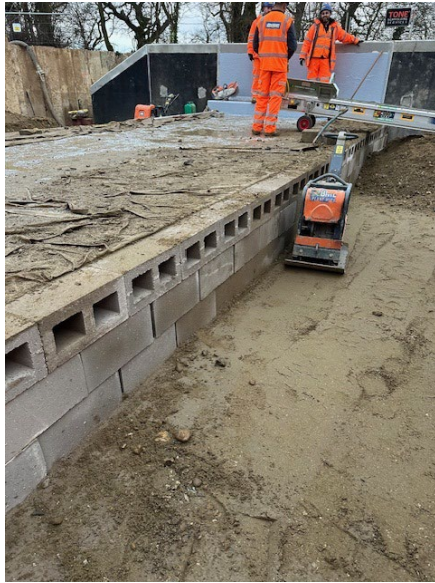
Image 1 - 6n Backfilled and hollow blocks installed

Once the waterproofing was complete, we placed hollow blocks against the culvert's walls. These blocks allow for drainage behind the walls, helping to relieve hydrostatic pressure that can build up and threaten the structure's integrity.

The next step involved backfilling with 6N material, a type of compactable aggregate, up to the level of the weep holes in the culvert structure. Weep holes are small openings that allow water to drain out, preventing it from accumulating and exerting pressure against the culvert. After reaching this level, an additional 6N material was added up to the sub-surface level of the planned road, providing a stable foundation for the road construction above.

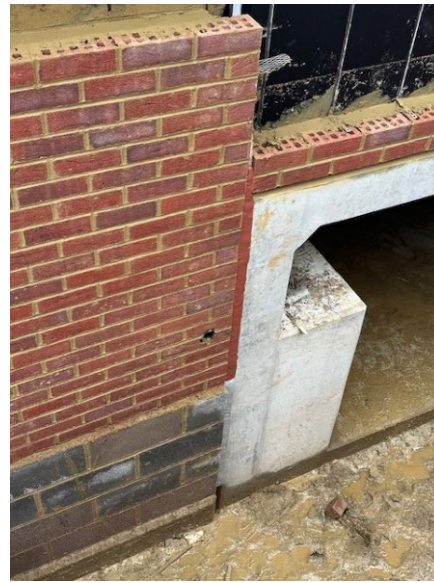
Image 2 - Brickwork on face of culvert

We also installed block-up brickwork on the face of the culvert. This step involved placing bricks on the exterior surface to make the culvert look better and help protect it.

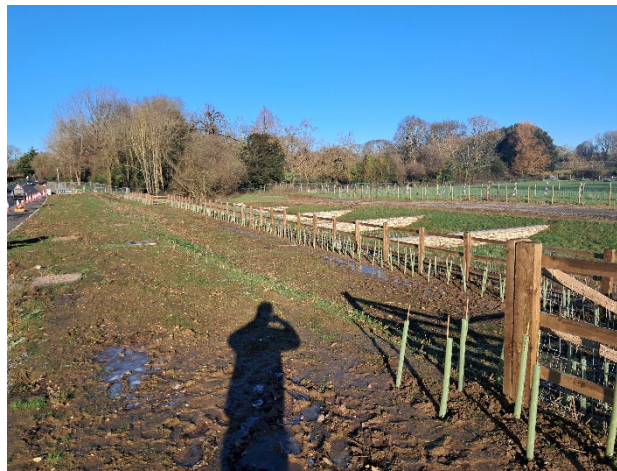
Image 3 - landscaped areas

In the landscaping areas, we prepared the ground and planted hedging whips. This helps establish new hedge lines and supports biodiversity around the project area.

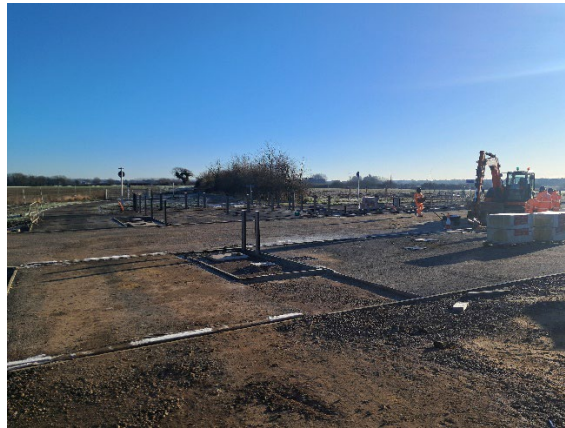
Image 4 - Pegasus crossing and fencing beams

At the same time, over at the pedestrian farm access and horse crossing known as Pegasus Crossing, we've been busy laying and testing underground ducting to ensure they can house the cables for street and traffic signal lighting. This is important for things like traffic lights and sensors that help keep the crossing safe and functional.

We've also installed new timber fencing beams around the crossing to define the boundaries between different crossing areas. This fencing will then separate the areas used by pedestrians, horses, and farm vehicles, ensuring that each has a designated and safe path to cross.

Traffic loops were installed at the Pegasus crossing, which is essential for detecting vehicles and helping to manage the traffic flow safely and efficiently. These loops are embedded in the road surface and connect to the traffic signal system to control light changes based on the presence of vehicles.

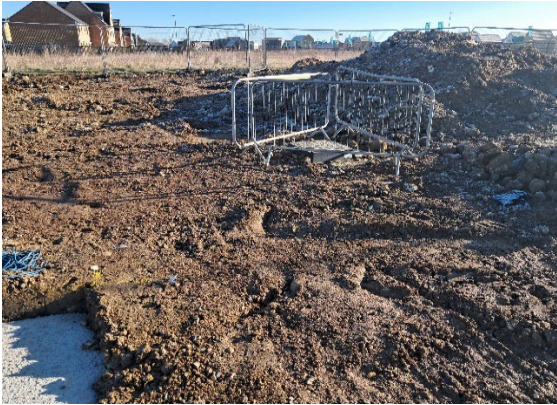
Image 5 - Attenuation tank rodding eye

We also installed a rodding eye to the attenuation tank; this is a maintenance access point that helps ensure our drainage system continues to function properly. Moreover, we fully installed the ducting for future street lighting, laying the groundwork for enhancing safety and visibility once the lights are activated. These updates are part of our ongoing efforts to improve safety and efficiency in the area.

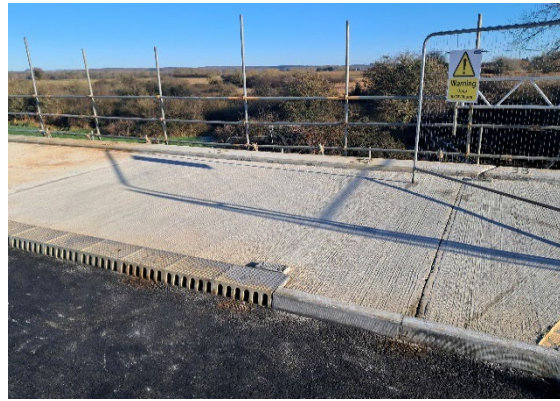
Image 6 - Concrete infills on viaduct

Additionally, we added concrete along the edges of the bridge to prepare for a new layer of tarmac. This preparation ensures that the pathway will be robust and durable.
