Isohyet map showing approximate rainfall coverage and properties affected during June 2012 flooding

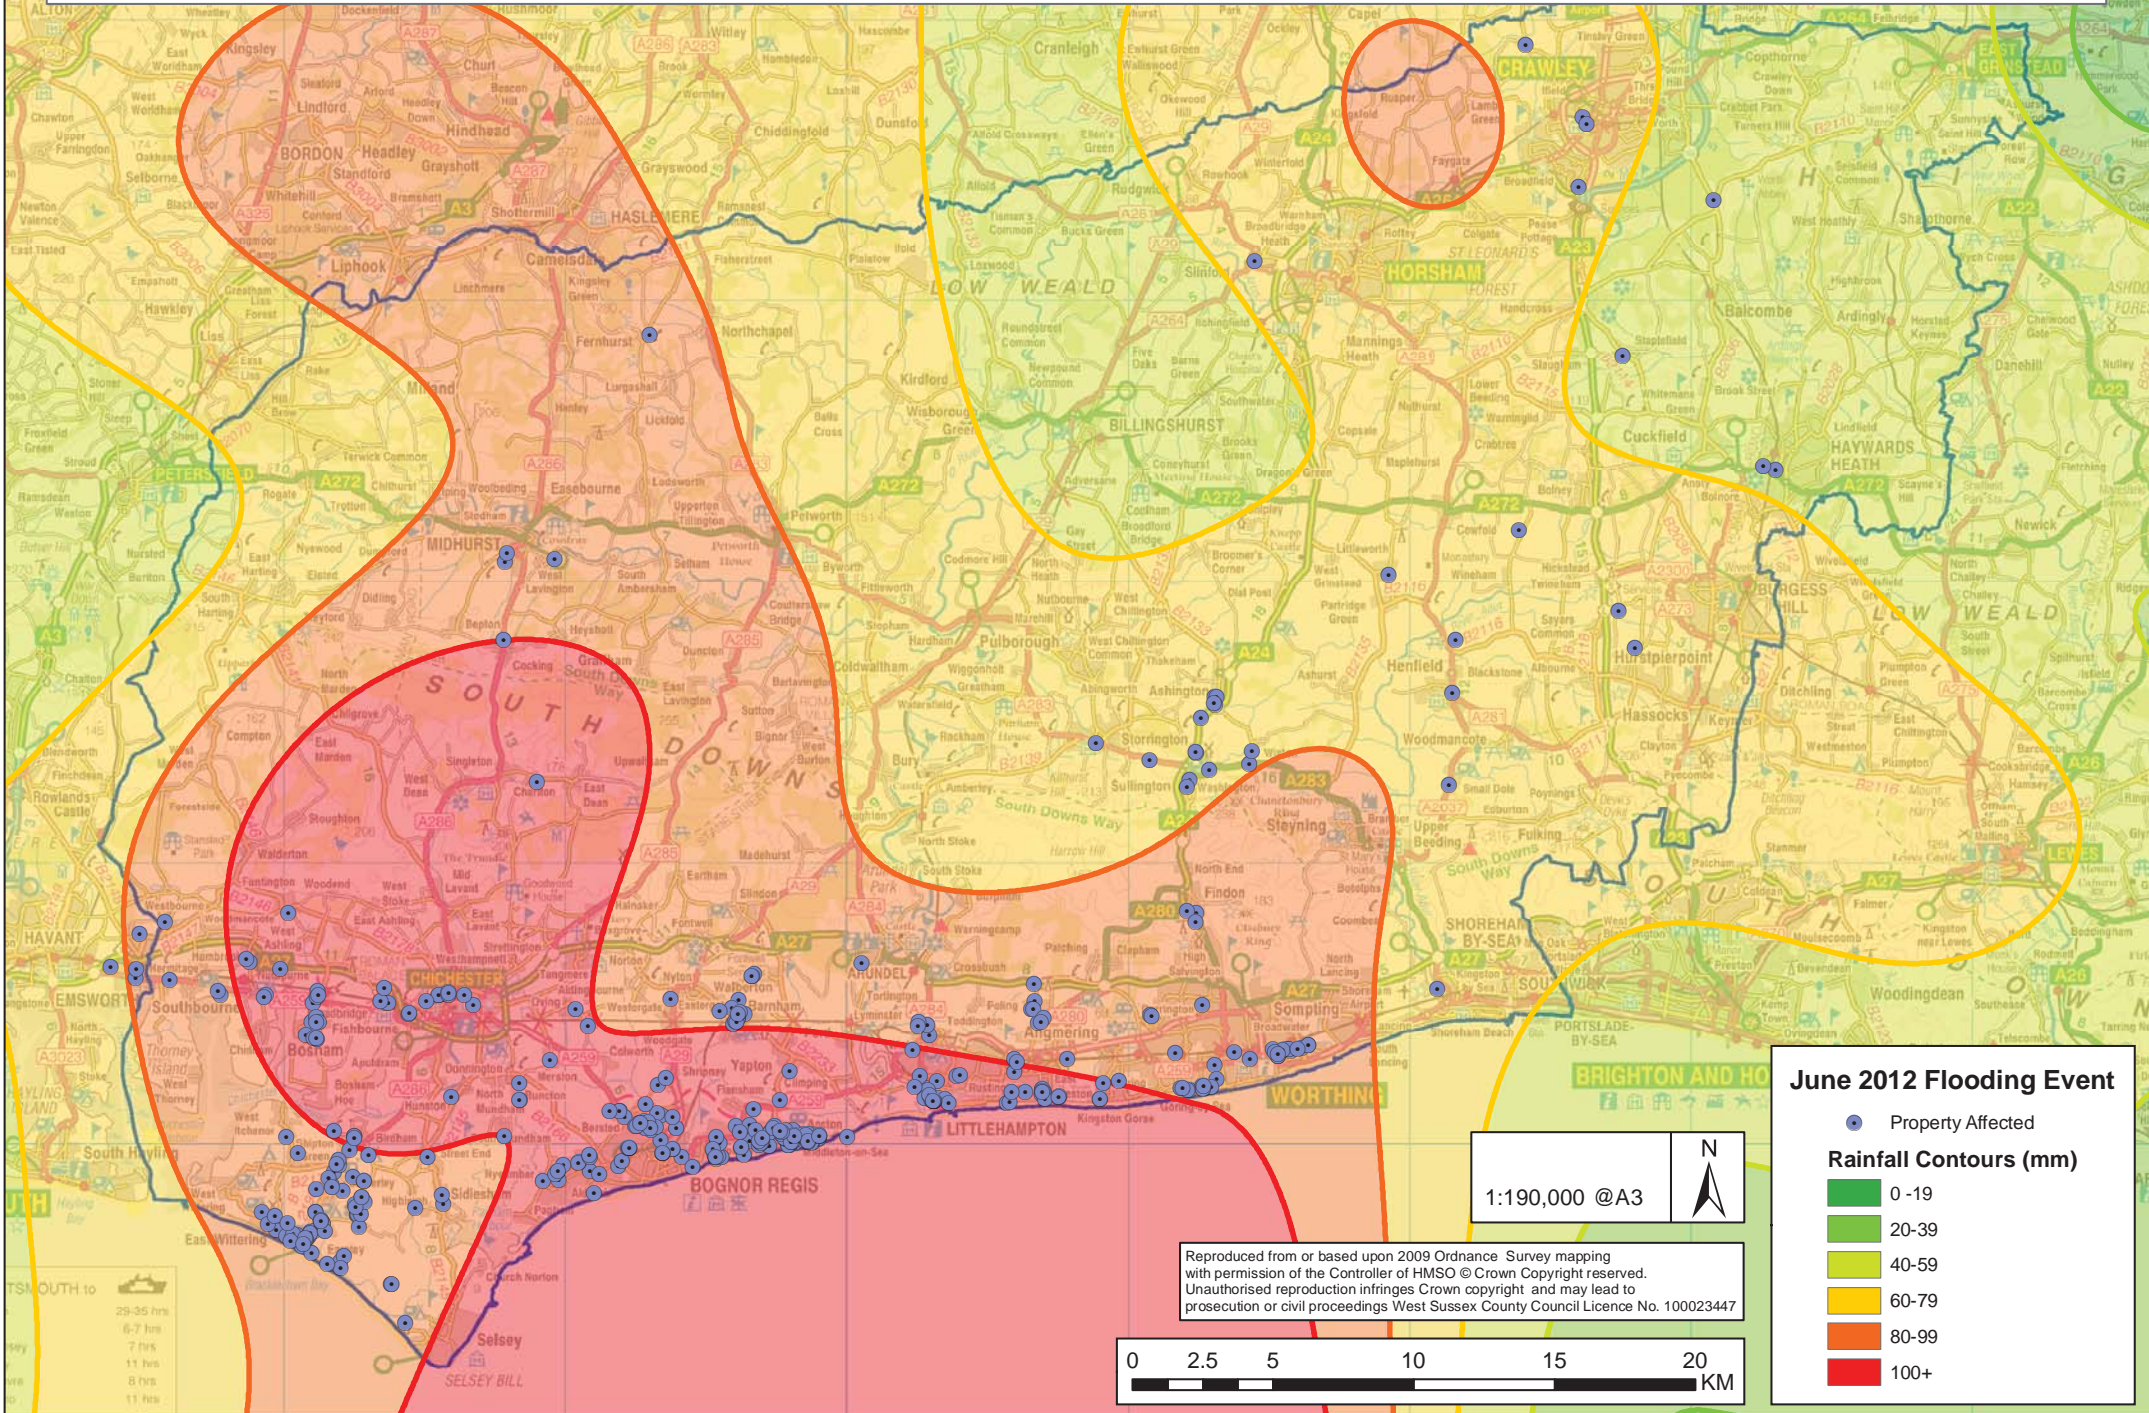
Figure 4. Typical Rainfall Coverage and 'Properties Affected'.
