A284 Lyminster Bypass (North) – Progress Update

Date: 31/01/24

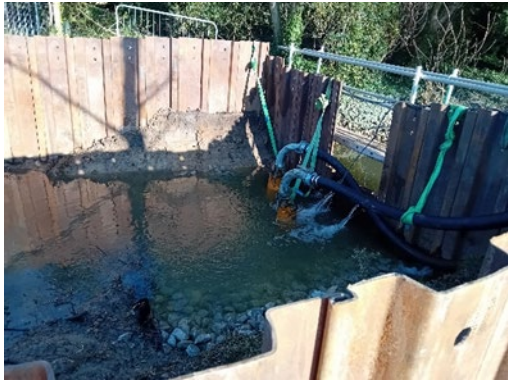
Image 1 Cofferdam with over pumping.

Over pumping has begun so the water in Brookfield stream, East of the A284, is temporarily diverted along pipes under the road back into the stream, West of the A284. In preparation for this, sheet piles were put in a square formation, creating a cofferdam, to block off the water from flowing into the culvert and to allow the rate of the flow to be controlled, ensuring the pumps will keep the water level of the stream constant. A fish rescue team arrived on site to use the technique “electrofishing” to move what was found in the sectioned off part of the stream, to a safe location downstream. An eel, a baby pike and a few nine-spine stickleback fish were found and moved downstream.

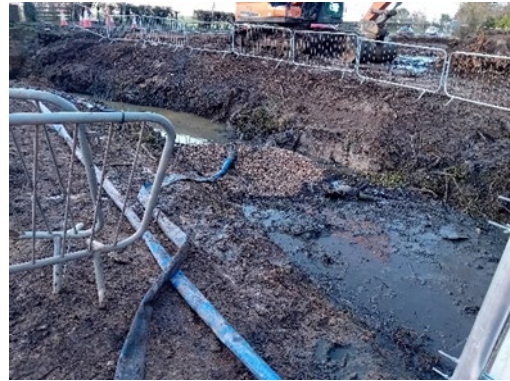
Image 2 location of new culvert.

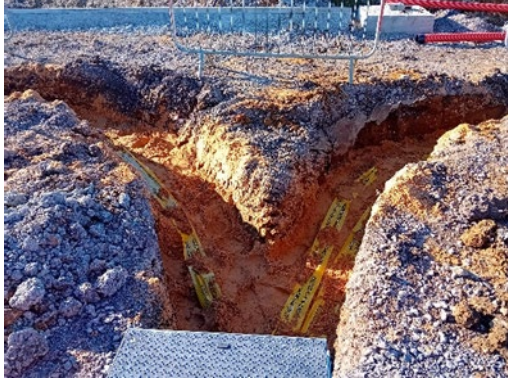
Image 3 Street lighting ducts into box.

As part of our final design, we have a Pegasus crossing which involves an equestrian, agricultural plant, pedestrian and cyclist crossing. For this crossing, we have installed a total of 8 streetlights and traffic light signal boxes/sockets and have connected street lighting ducts. Once the surfacing is completed we will install the poles for the traffic lights and streetlighting in these sockets and pull the electric cables through the ducting network.

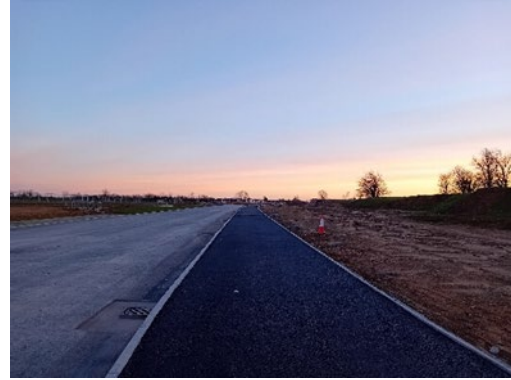
Image 4 Footpath with tarmac base course

Our footpath is starting to be built up now with us completing another phase, this included laying 175 metres of tarmac base course.

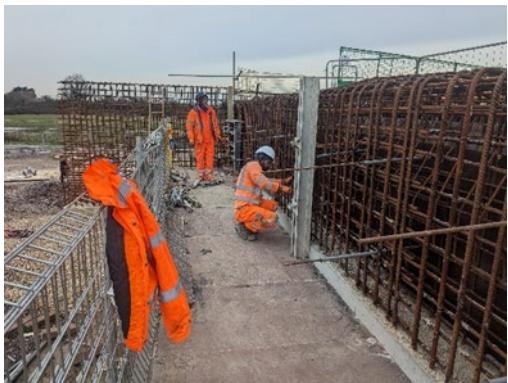
Image 5 North abutment reinforcement.

This month we have completed the North abutment's steel reinforcement. In total we have now completed 90% of the steel works for the viaduct and plan to have this fully complete in the next couple of months.

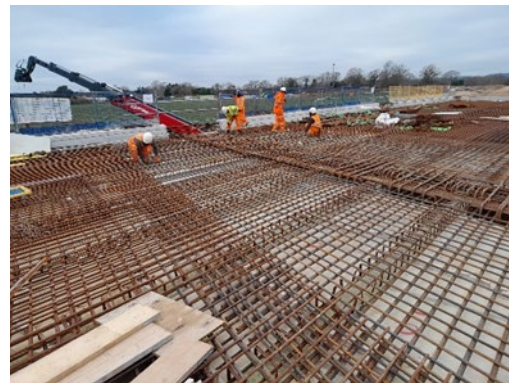
Image 6 Steel work progress

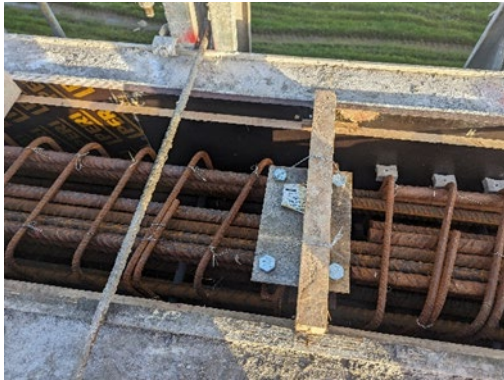
Image 7 Bolt cluster for parapet.

As part of the design, we have positioned bolt clusters along the edge (parapet) of the viaduct, allowing the safety fencing (VRS) on the bridge to be installed. The VRS is used to absorb and decrease the force of a crashing vehicle.

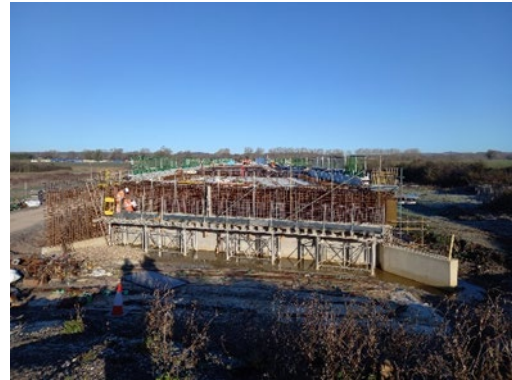
Image 8 View of viaduct facing North.

We have now poured 30% of the concrete deck, the bypass consists of two abutments and 10 piers, with January's focus on pouring concrete for pier 8 and 9 as well as the North abutment wing wall. The wing walls for both the North and South abutment are there to provide structural support for the viaduct, the abutments are the ends of the viaduct.
