A284 Lyminster Bypass (North) – February Progress Update

Date: 06/03/24

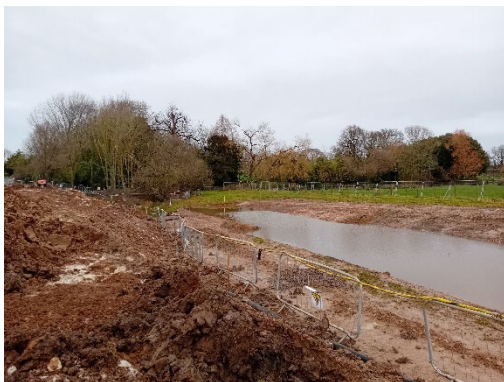
Image 1 Newly dug swale.

We have dug out our Northern swale which connects to the drainage of the new Lyminster Bypass and outfalls into Brookfield stream. This acts as a catchment for water, slowing down the rate it goes into the stream. With the drastic recent increase in rainfall, our swale has worked as an extra water store.

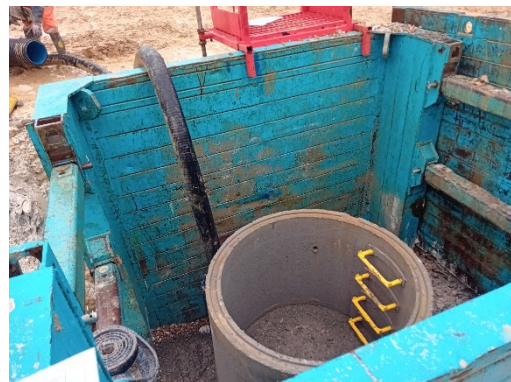
Image 2 Water pump in manhole trench box.

Due to the area being a flood plain and a having a high-water table we continuously fight against ground water. To ensure drainage works can continue, any hole that is dug below the water level we use a pump to transfer the ground water back into the river. We have done this with our manhole installation by using a manhole trench box with a slightly deeper area where the pump can sit. This allows us to lay our drainage pipes and bed the manhole in concrete keeping it in place.

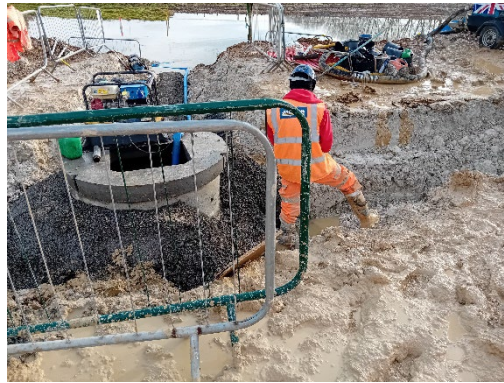
Image 3 Continued drainage works.

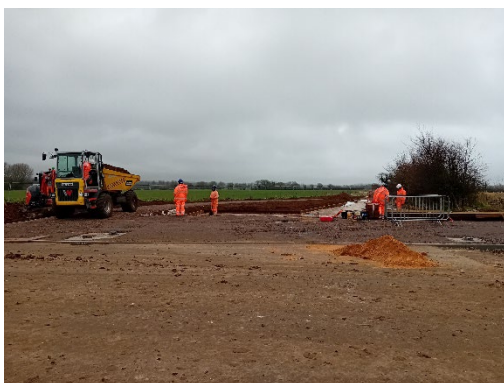
Image 4 Pegasus crossing.

This month we have focused on getting the foundations of the pegasus crossing fully completed. The Pegasus crossing is where the existing bridleway crosses the new road. It is designed to provide three separate crossings for pedestrian, equestrian and agricultural plant with a single traffic light for traffic on the carriageway. To ensure the bridleway is built with the designed curve, we use a surveying device called a total station. This measures angles and distances and is equipped with a computer programmed to allow us to set out the design to the nearest millimetre. The design was marked out with metal pins which were hammered into the chalk. Wooden edgings then got laid following this curvature and Type 1 aggregate was placed on top.

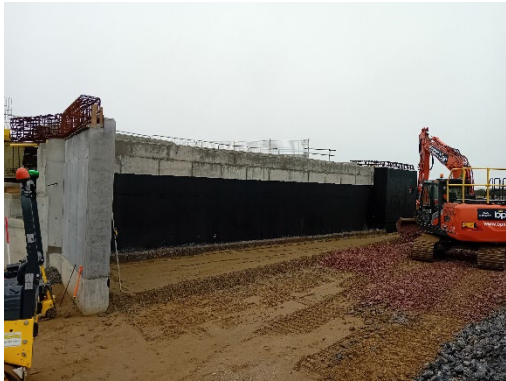
Image 6 North abutment.

‘Back of wall’ drainage on the North Abutment is ongoing. The excess runoff from the road will get transferred down into filter drains and eventually will run off into the swale. The filter drains and the swale provide natural filtration to the runoff from the road, ensuring the water is clean when it flows into Brookfield Stream.

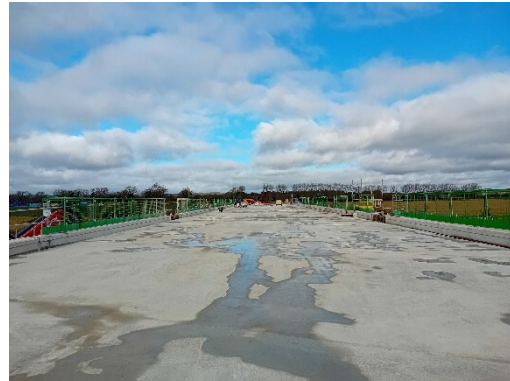
Image 7 Concrete deck on viaduct.

As we are coming to the end of the concrete pours for the viaduct, we have started to 'bridge the gap' between the viaduct and our newly built road. The embankment near the bridge is currently being constructed to allow access up to the deck. To reduce settlement, the type of material used is

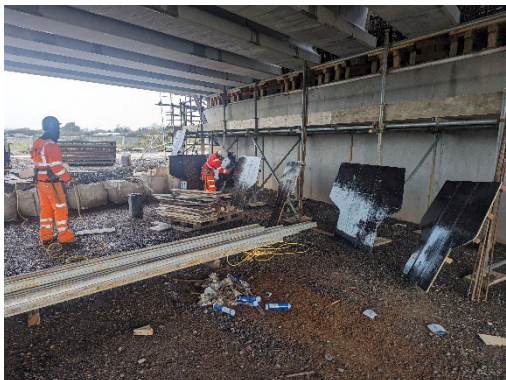
Image 8 Shutters ready for instalment.

For every concrete pour that goes into our bridge piers, we stop the concrete from flowing into areas we do not want it to by using timber board shutters. These are unique to the gaps between each beam and ensure the concrete stays in place and allows enough concrete cover for the steel reinforcement. The shutters get propped up with wooden supports, meaning although it is a lengthy process, the craft of the carpenters ensure a smooth concrete finish on each pier.

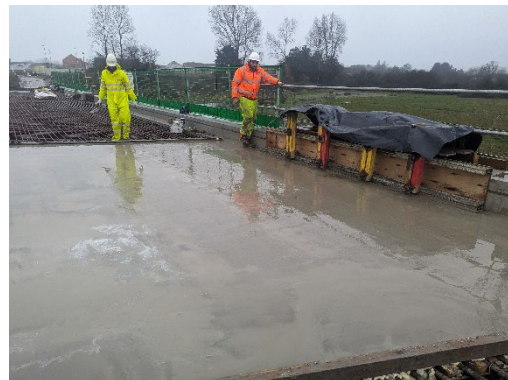
Image 9 Fresh concrete pour.
